GMT 400/900 SERVICE BULLETIN

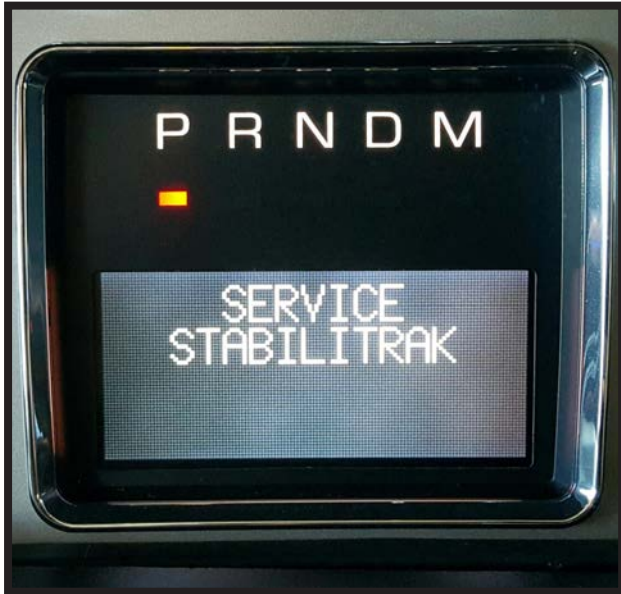
Service Notice

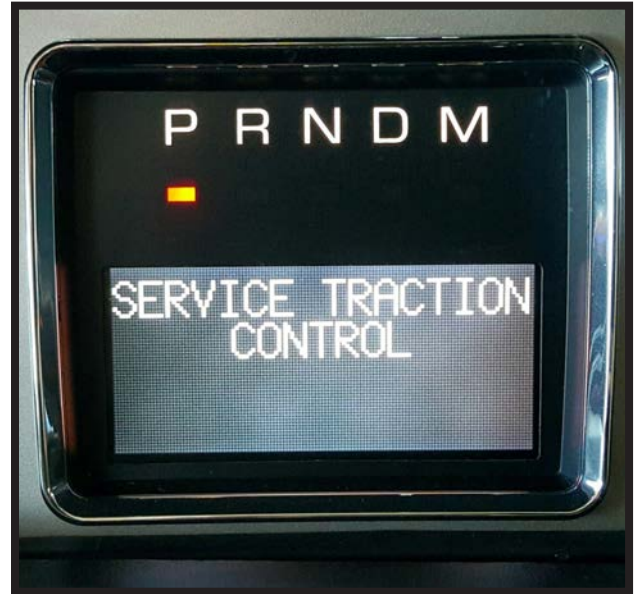
Service Notice

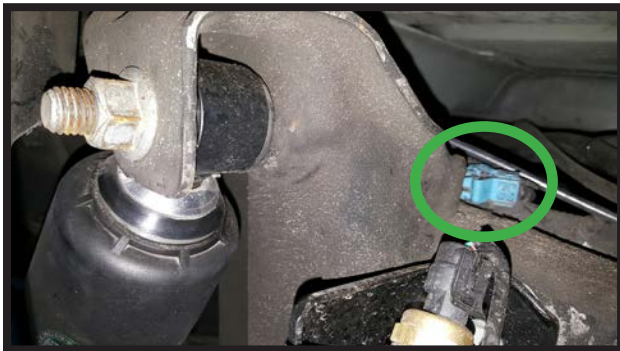
When replacing the rear shocks on these vehicles and accessing the upper shock mounting bolts, there is a high probability that the depicted blue electrical connection for the ABS wiring harness will come unplugged. When faced with this error message after performing a rear shock replacement, check their two connectors, located on each side of the vehicle, on top of the frame rail just behind the upper shock tower. Ensure the connections are good and restart the vehicle.

ABS Wiring Harness

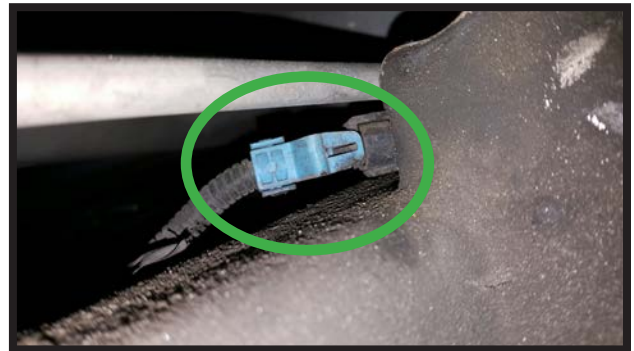
ABS Wiring Harness
