SERVICEINFO

STEERING KNUCKLE

AIC article no.: 59437 + 59438 / OE reference no.: 1 474 291 + 1 474 288

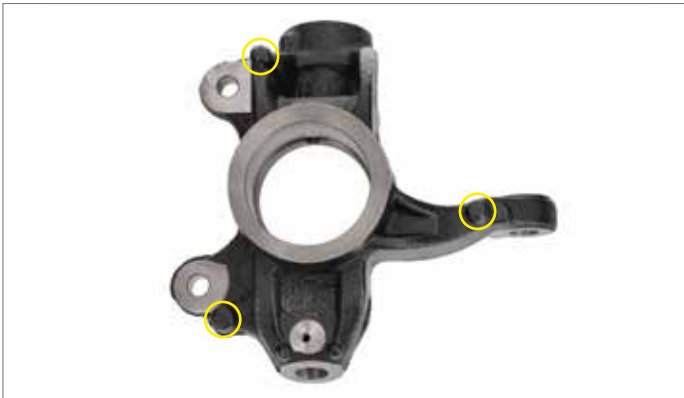
AIC article no.: 59437 | OE reference no.: 1 474 291

Before installation, the 3 threads (see markings) for attaching the shielding plates must be drilled, as these are not present.
