Brake Judder – Cause and Prevention

When fitting new brake discs and pads, careful preparation is vital to avoid brake judder.

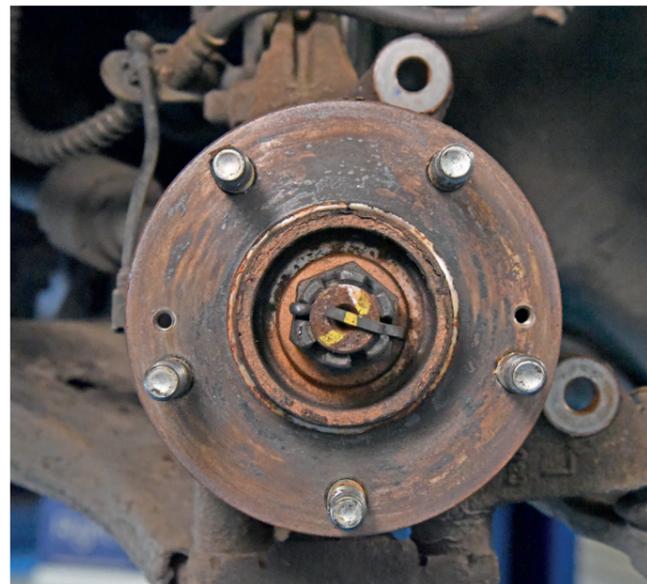
Figure 1

The mating surfaces of the brake disc or wheel hub can be the main cause of this excessive 'run-out'. If the mating surface is worn or not completely clean (Fig 1) – for example a small particle of grit or rust measuring just 0.05mm on the hub – the result could be a 'run-out' figure of over 0.10mm when measured at the contact surface of the brake disc. (Fig 2)

It is important to thoroughly prepare all mating surfaces and remove any corrosion from the wheel hub to ensure it is clean and free from defects. Then, using a suitable solvent such as brake cleaner, remove any traces of the anti-corrosion preservative from the new brake disc faces before fitting.

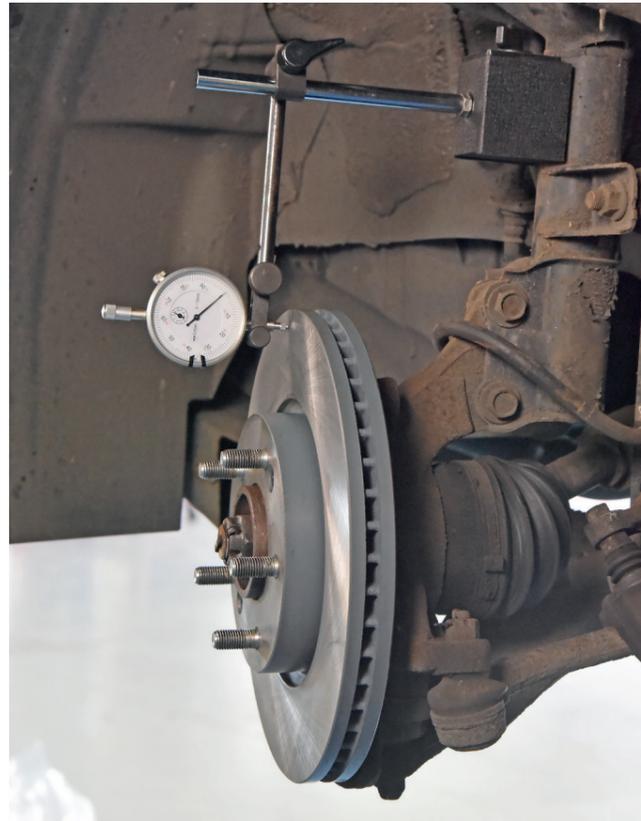
Figure 2

Brake disc 'run-out' must be checked with a dial gauge (Fig 2) with the brake disc secured to the hub, taking note of the point of maximum variation. The utmost recommended 'run-out' is 0.10mm - however, this number may be lower subject to the vehicle manufacturer's specification.

If the 'run-out' figure is indeed excessive it may be possible, depending on vehicle application, to fit the disc in an alternative radial position on the wheel hub - i.e. turned through 90° and then re-assembled.

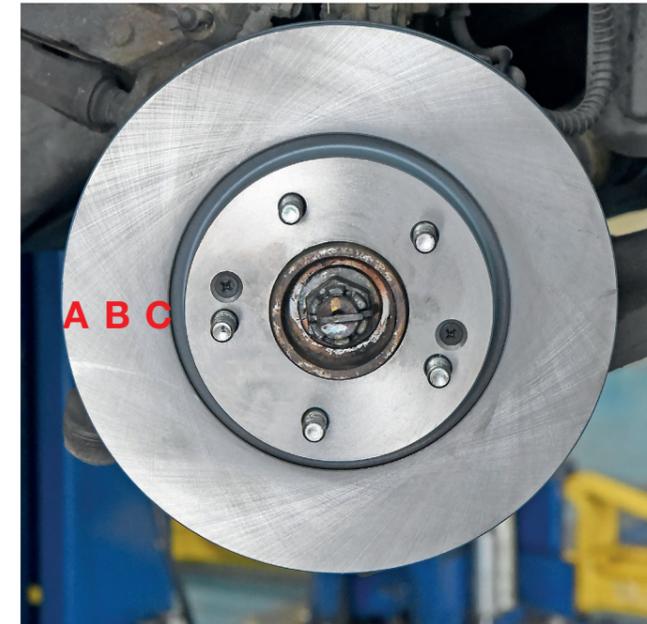
Figure 3

D.T.V. of the brake disc can also be measured separately using a micrometer; the measurements should be taken at points A, B, and C (Fig 3) at various positions around the disc. Variation in thickness of as little as 0.025mm can cause vibration and judder when under braking, and with some vehicles, this figure can be even lower.

D.T.V. is usually created by the disc running out of true and making partial contact with the brake pads when the brakes are not being applied. At these localised points of contact the disc is worn at a greater rate than normal and as such variation in the thickness of the disc occurs. When this happens, the vibration under braking will become apparent.

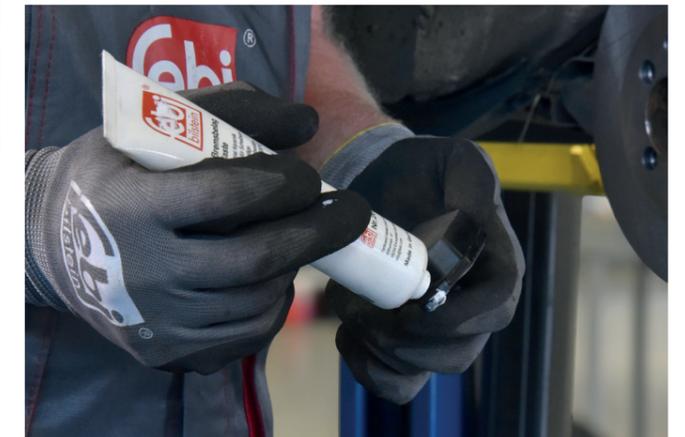
Figure 4

- Check operation of parking brake mechanism.
- Check the condition and operation of the caliper sliding points.
- Depending on the brake design, be sure to also clean the caliper bracket guide surfaces.
- Check the brake caliper, bracket, fixings, guide plates and other small system parts for rust and damage and replace if necessary.
- Use a high-temperature-resistant and metal-free grease such as ceramic paste to lubricate the mounting surfaces, along with the guide and contact surfaces on the caliper bracket and brake pad. (Fig.4)

Remove all surface rust from the brake pad mounting area.
